Assessment of the Structure of Public Elementary School 28 Air Tawar Timur Padang

The State Elementary School 28 Air Tawar Timur Padang is an Inpres School which was built in 1982. The current condition of the school building is damaged, such as cracks, loose concrete (spalling), deflection and shaking floors. This study aims to provide recommendations for repair or maintenance of the school building. The assessment method used in this study is the Non Destructive Test (NDT) method. Testing the compressive strength of concrete using a Schmidt Rebound Hammer. To see the amount of reinforcing steel, diameter of reinforcing steel and dimensions of structural elements using a Rebar Locator, Caliper, and a meter. Testing the building geometry and deflection floor plates using Total Station and Laser Measurement. The building structure was analyzed using the SAP2000 program. The results of the concrete compressive strength test (f_c') are on average 20.40 MPa on the column, 22.23 MPa on the beam, and 23.43 MPa on the floor plate. The results of visual observations of the building are categorized as severely damaged with the proportion of damage above 20%. Where the proportion level of c

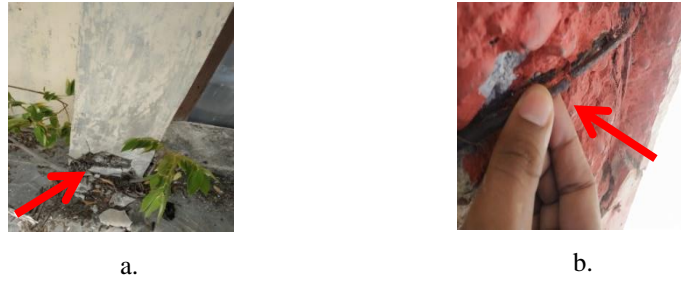
Based on visual inspection (visual check) it can be seen that certain structural elements have been damaged, such as dampness, cracks, and spalling which shows that the reinforcement has been corroded and broken stirrups are found. The percentage of damage that occurred in the column is 32 %, where the column is included in the category of heavily damaged which is greater than 20% [5].

Figure 3. a. Spalling on Columns, b. Broken stirrup

Based on the research and data analysis that has been carried out, it can be concluded that the State Elementary School 28 Air Tawar Timur Padang from visual observations is included in the category of heavy damaged, which is greater than 20%. From the results of the structural evaluation, almost all structural components are categorized as unsafe except for Beams 3, Beams 4, and Columns 2. The actual deflection of the slabs exceeds the allowable deflection of the floor slabs. So the recommendation for building repair or maintenance is the overall renovation of the building.

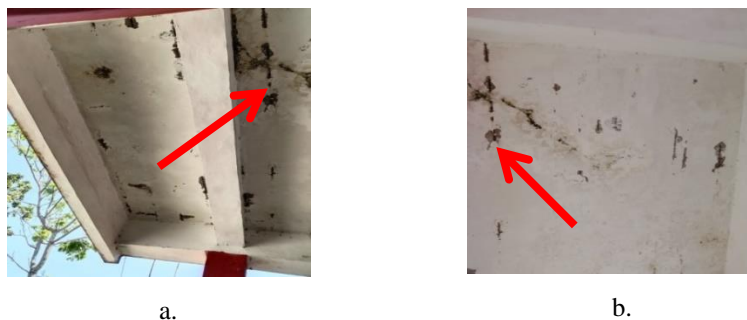
The results of visual observations on the slab components, show that the condition of the slab looks bad. In almost every room in the school, the slabs were heavily spalled and exposed the reinforcing steel to corrosion. In addition, the school floor vibrates when carrying out activities. The percentage of damage that occurs to the slabs is 65%, where the slabs are categorized as heavily damaged, which is greater than 20% [5].

Figure 5. a-b. Spalling On Plate

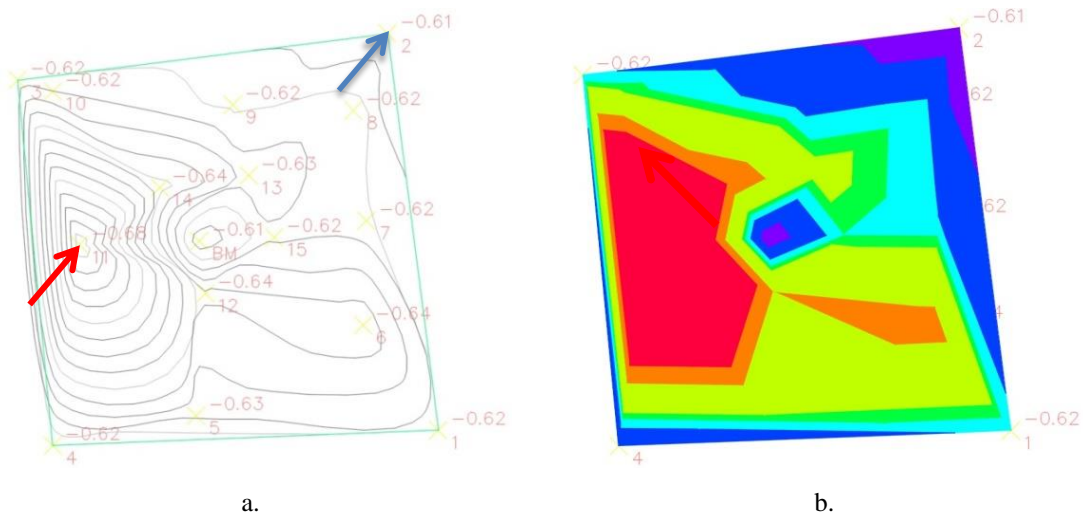
Based on the results obtained from the Total Station tool, the deflection of the slab is presented in Table 5. The maximum deflection occurs in Class V with a deflection value of 73 mm, which can be seen in Fig 6 and Figure 7. Analysis of the structure of the 28 Air Tawar Timur Padang Elementary School building assumes that the structure applied is a Special Moment Bearing Frame System using a gravity load model on beam elements and uniform load on floor slabs. The earthquake loading model on the building structure uses equivalent static analysis. The results of the structural analysis (output) are in the form of internal forces (axial force, shear force, and moment).

Figure 6. a-b. Floor Plate Maximum Deflection

The building of State Elementary School 28 Air Tawar Timur Padang is included in the heavy category of damage, where all structural and non-structural elements that are reviewed are included in the heavy category, which is greater than 20%. From the results of the evaluation of the analysis of building structures that have been carried out, almost all structural elements are not included in the safe category against bending moments, shear forces, and axial forces except for Beams 3, 4, and Columns 2. In addition, the actual deflection value of the floor slab is in classes III, IV, and V are 38 mm, 35 mm, and 73 mm, greater than the allowable deflection of 18.9 mm.
